# Stream Bank Assessments

Greenway Team

By: Gavin Witherspoon

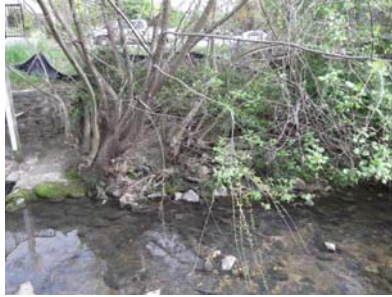
Near Bridge in Maxcy Gregg Park

**Sight 1, Bank 1:**  
Bank slope greater than 45 degrees and 26%-50% ground cover. Is prone to erosion. **B2**

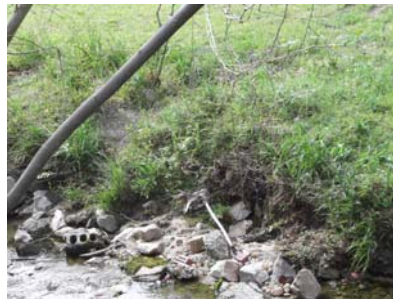
**Sight 1, Bank 2:**  
Bank slope greater than 45 degrees and 51%-75% ground cover. Is prone to erosion. **C2**

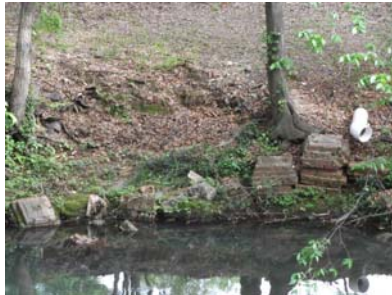
Blatt side of the Pickens Bridge

**Sight 2, Bank 1:**  
Bank slope less than 45 degrees and 0%-25% ground cover. Is prone to erosion. **A1**

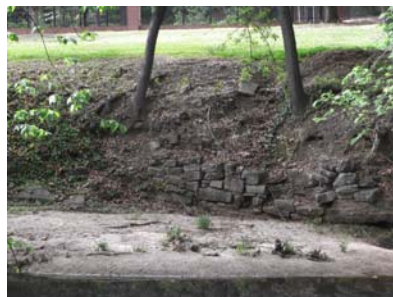
**Sight 2, Bank 2:**  
Bank slope greater than 45 degrees and 0%-25% ground cover. Is prone to erosion. **A2**

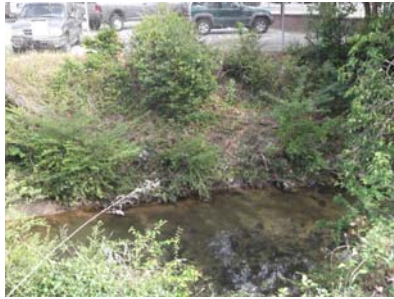
**Beside Navy ROTC Building**

**Sight 3, Bank 1:**  
Bank slope greater than 45 degrees and 51%-75% ground cover. Is prone to erosion. **C2**

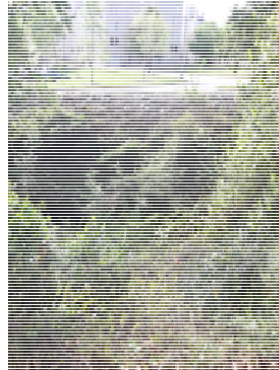
**Sight 3, Bank 2:**  
Bank slope greater than 45 degrees and 51%-75% ground cover. Is prone to erosion. **C2**

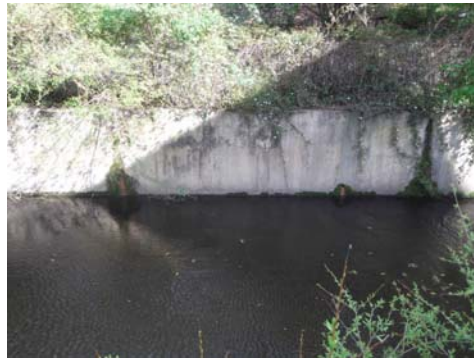
**Behind Blatt PE Center**

**Sight 4, Bank 1:**  
Bank slope greater than 45 degrees and 0% ground cover. Is not prone to erosion. **A2**

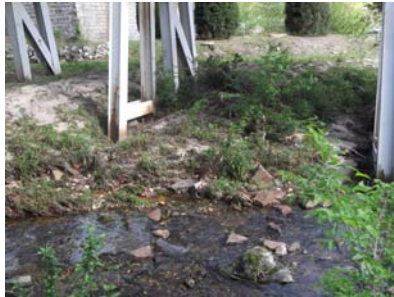
**Blatt side of Sumter Street behind the softball field**

**Sight 5, Bank 1:**  
Bank slope less than 45 degrees and 0%-25% ground cover. Is not prone to erosion. **A1**

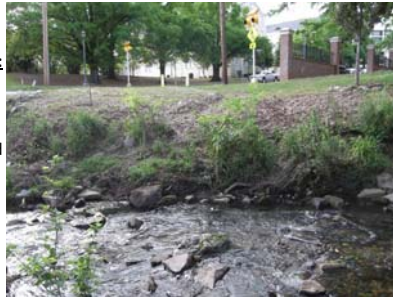
**Sight 5, Bank 2:**  
Bank slope less than 45 degrees and 0%-25% ground cover. Is not prone to erosion. **A1**

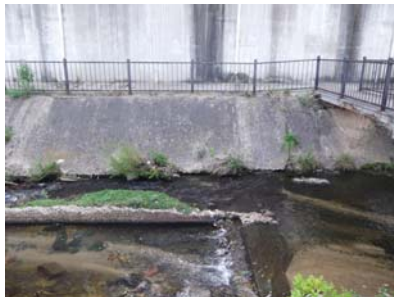
**Behind 300 Main Building**

**Sight 6, Bank 1:**  
Bank slope greater than 45 degrees and 0% ground cover. Is not prone to erosion. **A2**

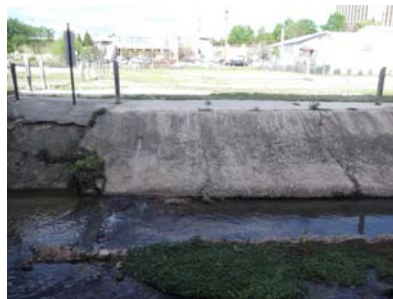
**Sight 6, Bank 2:**  
Bank slope greater than 45 degrees and 0% ground cover. Is not prone to erosion. **A2**

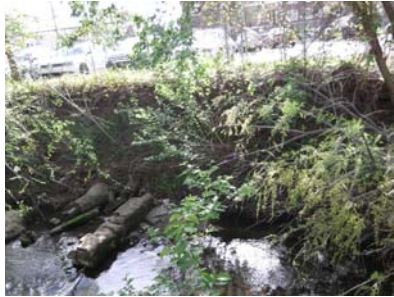
**Between the parking lot to the right of 300 Main and the Biomass Facility**

**Sight 7, Bank 1:**  
Bank slope greater than 45 degrees and 26%-50% ground cover. Is prone to erosion. **B2**

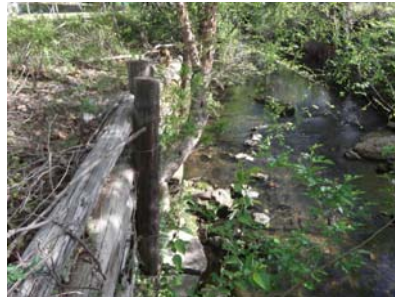
**Sight 7, Bank 2:**  
Bank slope greater than 45 degrees and 0%-25% ground cover. Is not prone to erosion. **A2**

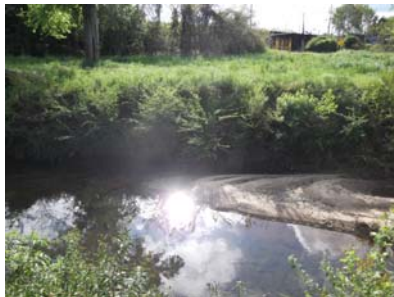
**Beside the gas station at the bottom of Main Street**

**Sight 8, Bank 1:**  
Bank slope greater than 45 degrees and 26%-50% ground cover. Is prone to erosion. **B2**

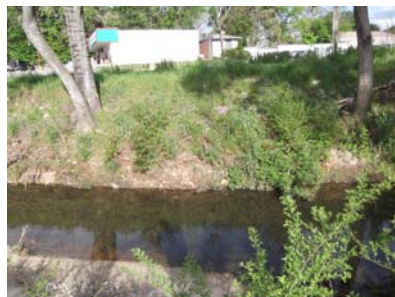
**Sight 8, Bank 2:**  
Bank slope greater than 45 degrees and 26%-50% ground cover. Is prone to erosion. **B2**
