# FLOODPLAIN SEDIMENTATION AND SENSITIVITY: SUMMER 1993 FLOOD, UPPER MISSISSIPPI RIVER VALLEY

BASIL GOMEZ<sup>1</sup>, J. D. PHILLIPS<sup>2</sup>, F. J. MAGILLIGAN<sup>3</sup> AND L. A. JAMES<sup>4</sup>

*Earth surf. process. landforms*, 22, 923–936 (1997)

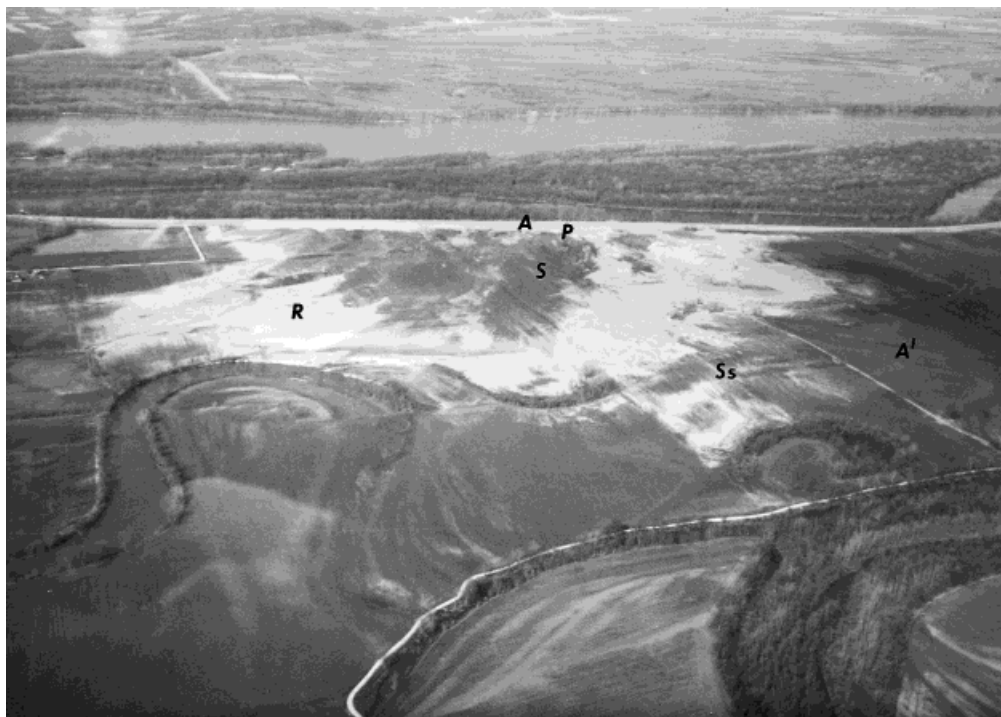
Figure 3. Levee break complex at Sny Island. The length of the section of levee shown in the photograph is about 2.25 km. P=pothole scour in the vicinity of the initial failure, S=stripped zone, R=sand rim, and Ss=sand sheet. A–A' indicates the location of the transect depicted in Figure 5.

The Sny Island levee break complex covered an area of about 2 km<sup>2</sup> in the immediate vicinity of the break site (Figure 3). It comprised a localized zone of concentrated scour, a more extensive zone of superficial stripping, and a circumjacent depositional zone. The levee borders McDonald Chute and is separated from the main channel by McDonald Island at low flows, but at the time the levee failed the depth of flow over the island was about 3 m. Although the final width of the break was about 1000 m, significant scour occurred only in the vicinity of the initial failure. The principal scour hole was of the order of 125 m long, 20 m wide and <2 m deep, and assumed the generalized form of the inverted frustum of an elliptical cone, with the deepest portion of the scour hole located on the floodplain side of the levee, downstream of the vena contracta (cf. Das, 1973). The volume of the scour hole was about 4000 m<sup>3</sup>. On the river side of the levee, scour upstream of the vena contracta directly linked the break site with the chute. Several smaller, secondary scour holes apparently developed on the opposing side of the breach as it widened, so that a pothole scour pattern was evidenced on the floodplain over a distance of about 300 m within the general vicinity of the initial break.

characteristically take the form of a horseshoe-shaped sand rim that encircles the stripped zone (Figure 3). At Sny Island, the sand rim had a gently ramped backslope, several hundred metres long, that terminated in a well-defined slip face (Figure 5). Sand thicknesses of 0.15 to 1.3 m were typically observed at the crest, the location of which was probably constrained in the period immediately following failure by the position of the hydraulic jump that marked the transition to rapidly decelerating, divergent flow on the floodplain. The traction carpet in the zone of divergent flow is manifest by a splay-like sand sheet or discontinuous sand streaks that extend out across the floodplain beyond the leading edge of the sand rim (Figure 3). Where the sand sheet was not present, there was an abrupt transition between the leading edge of the sand rim and the surrounding, undisturbed floodplain surface. In other locations, although the transition appeared abrupt, the sand sheet was draped with silt which had settled from suspension (Figure 3). However, there were no obvious horizontal laminations within this silt unit or within any of the other silt deposits we scrutinized, which were all massively bedded (cf. Singh, 1972; Ray, 1976).
