ROCKY BRANCH WATERSHED:

The Path Towards a Functional Greenway

Jim Olsen(G), John Hutchinson, Gabrielle Petty, and Gavin Witherspoon 4/23/2013

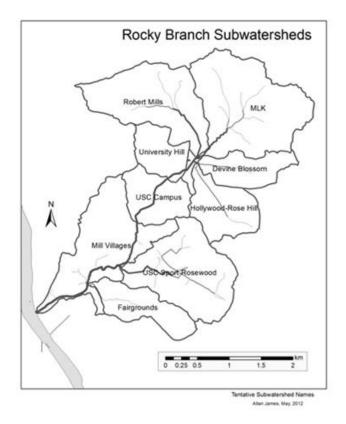
Figure 4.1: Map of the Rocky Branch subwatersheds (James, 2012).

The area of Rocky Branch focused on by myself and accessed by Gavin for a potential greenway was the portion of the creek flowing from the bridge at Maxcy Gregg Park to under the bridge at Main and Whaley Streets. The subwatershed the stream flows through in this area is the USC Campus (Figure 4.1). This portion of the stream is variable, as it flows through a variety of environments, for example, a park with less impervious surfaces, to just under a bridge

surrounded by a high percentage of impervious surfaces. John Wooten (2008) calculated the imperviousness of the entire watershed to be 49% and based on zoning classifications, estimated the future percentage of imperviousness to be 65.9%. This portion of the watershed is majorly zoned as general commercial (Wooten, 2008). In terms of the whole watershed, "general commercial had the highest percent imperviousness of all land uses" (Wooten, 2008). Based on these factors, it can be assumed that this subwatershed of Rocky Branch has a high percentage of impervious surfaces, compared to other subwatersheds of Rocky Branch. Since 2008 (Wooten's study), many construction projects and the addition of new buildings, parking lots, etc. have occurred in the USC Campus subwatershed, so it can be assumed that the percentage of impervious surfaces in this area has increased. A greenway would be very feasible because it would reduce the percentage of impervious surfaces in this area for the surfaces in this area. This in turn reduces the
