The Geological Society of America
 Special Paper 451
 2009

Historical channel changes in the lower Yuba and Feather Rivers, California: Long-term effects of contrasting river-management strategies

L. Allan James

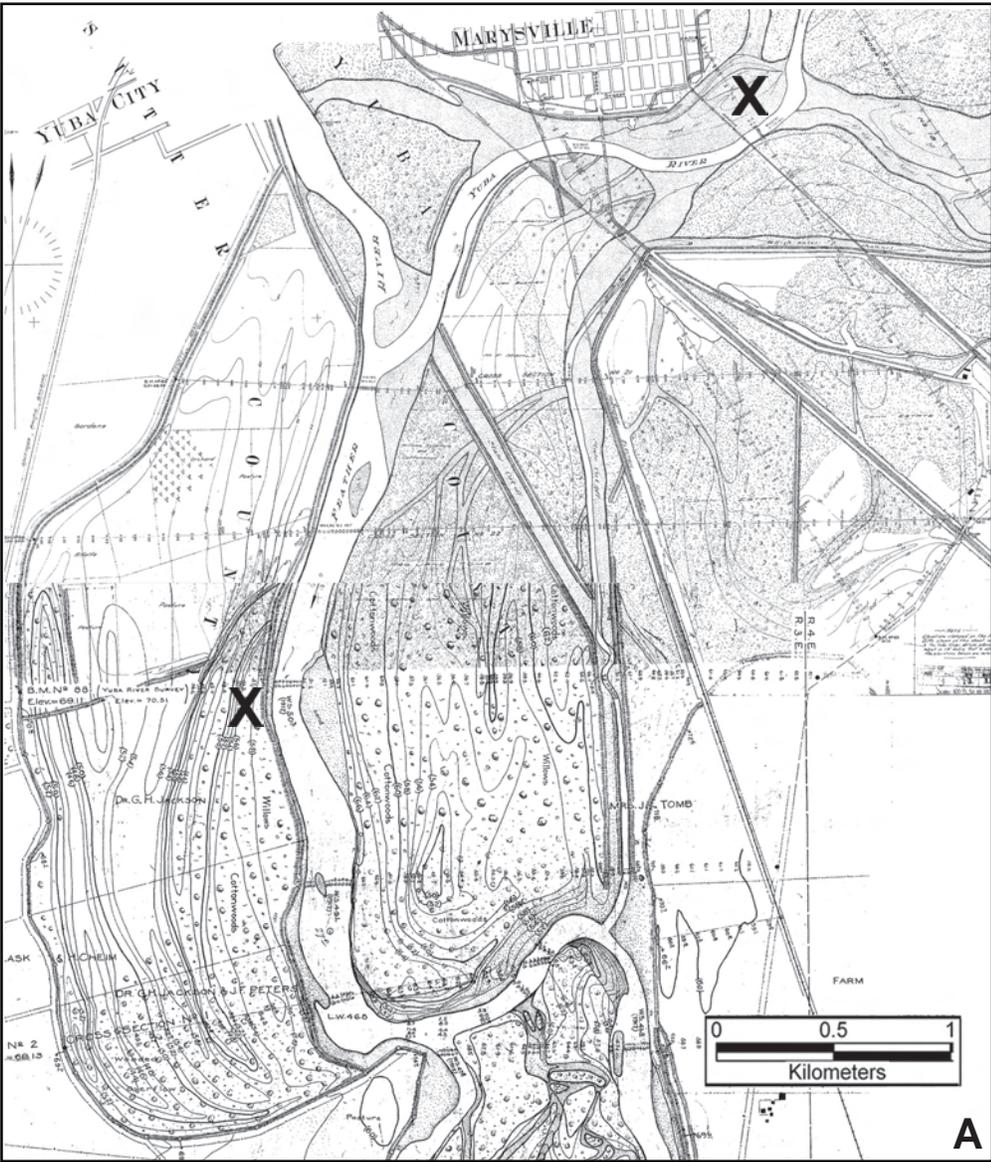
Figure 12. Channelization around Yuba-Feather confluence. Several ditches were dredged south of Marysville shortly before 1909. Two ditches connected with the Feather River at Elisa Bend, and another turned the confluence south. (A) Stratigraphic sections collected at XS are shown in Figures 13 and 15A. (Source: CDC, 1912.) (B) Ditches are prominent (cartographically exaggerated) on 1914 map. (Source: Crook, 1914.)

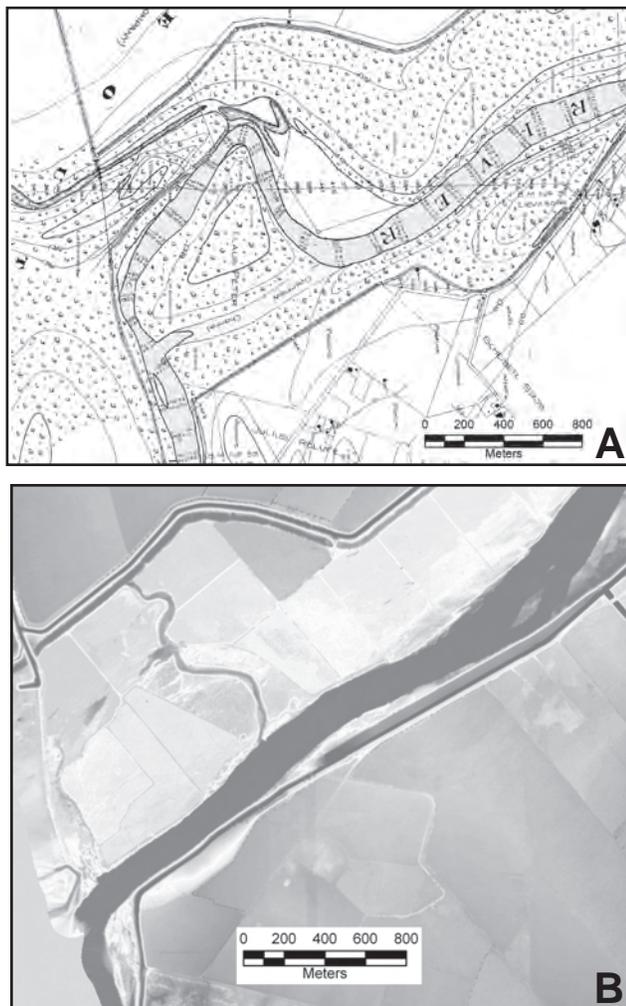
Figure 17. Lower Feather River at Sutter Bypass confluence. (A) 1909 CDC map: incipient cutoff of Nelson Bend. (B) Shaded-relief map with oxbow lake largely filled in 1999. Derived from LiDAR, a digital elevation model (DEM), and sonar channel bathymetry (Stonestreet and Lee, 2000; Towill, Inc., 2006).
